# FIELD INVESTIGATION TEAM ACTIVITIES AT UNCONTROLLED HAZARDOUS SUBSTANCES FACILITIES — ZONE I

FINAL DRAFT  
PRELIMINARY ASSESSMENT REPORT  
MEARL CORPORATION  
PEEKSKILL, NEW YORK

TECHNICAL DIRECTIVE DOCUMENT NO. 02-9102-08  
CONTRACT NO. 68-01-7346

JULY 9, 1991

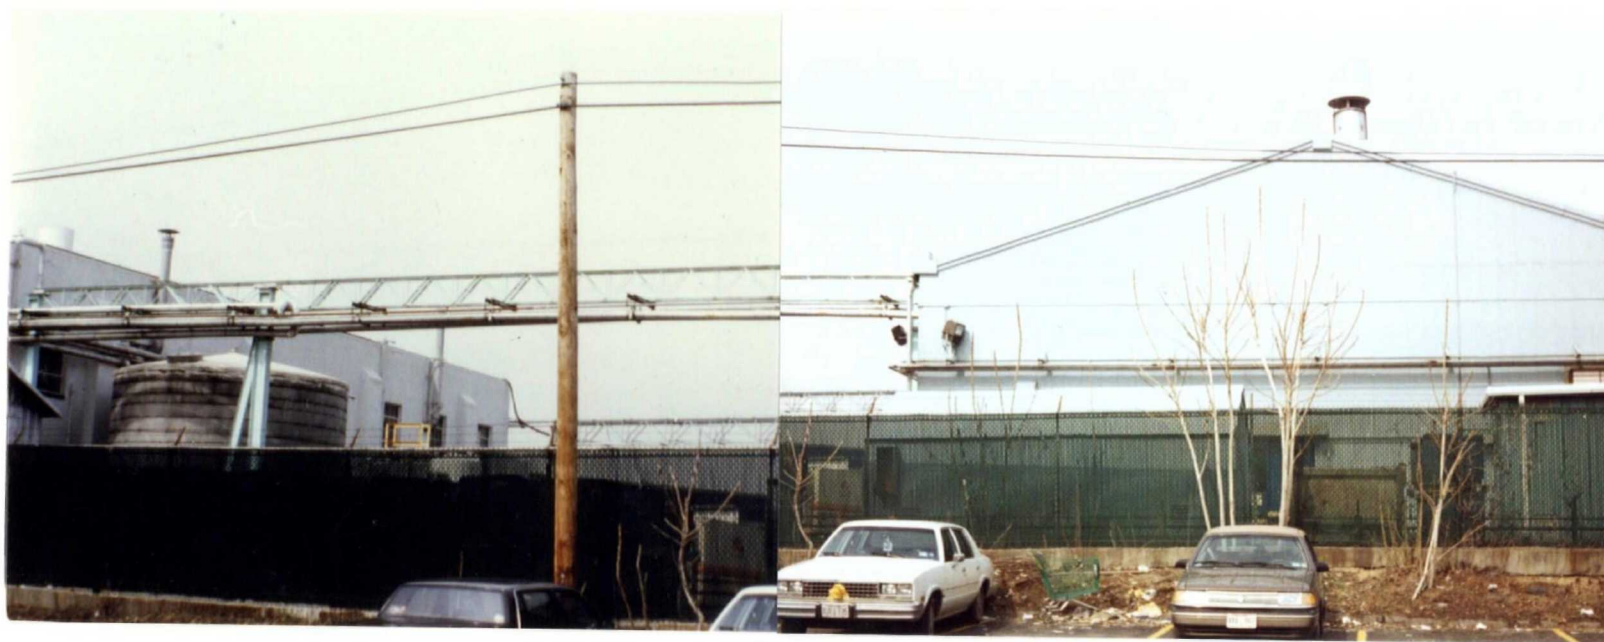
<u>Photo Number</u>	<u>Description</u>	<u>Time</u>
1P-2,3	Photo facing front northeast side of Mearl Corporation. Warehouse #1.	1256
1P-3,4	Photo facing middle northeast side of Mearl Corporation. Warehouse #2 and aboveground storage tank.	1256
1P-4,5	Photo facing rear northeast side of Mearl Corporation. Aboveground storage tank, silo and warehouse #3.	1256
1P-6	Photo facing northeast front entrance administrative building and guardhouse.	1302

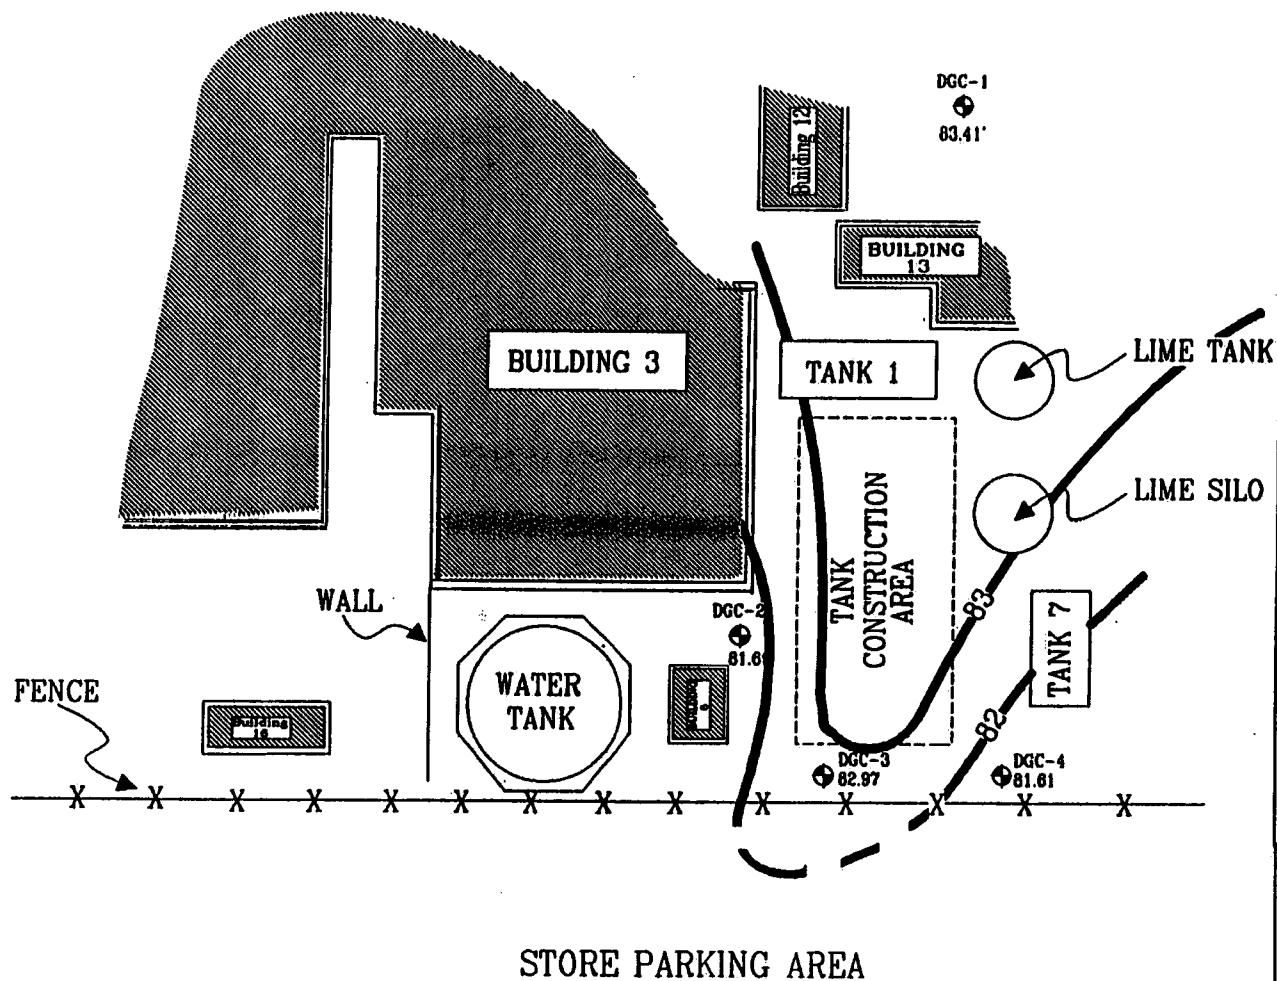
The water table was encountered at approximately 12 to 15 feet below grade. Figure 3 shows the groundwater contours for water level readings taken on January 30, 1990. Site groundwater flow is generally towards the southwest.

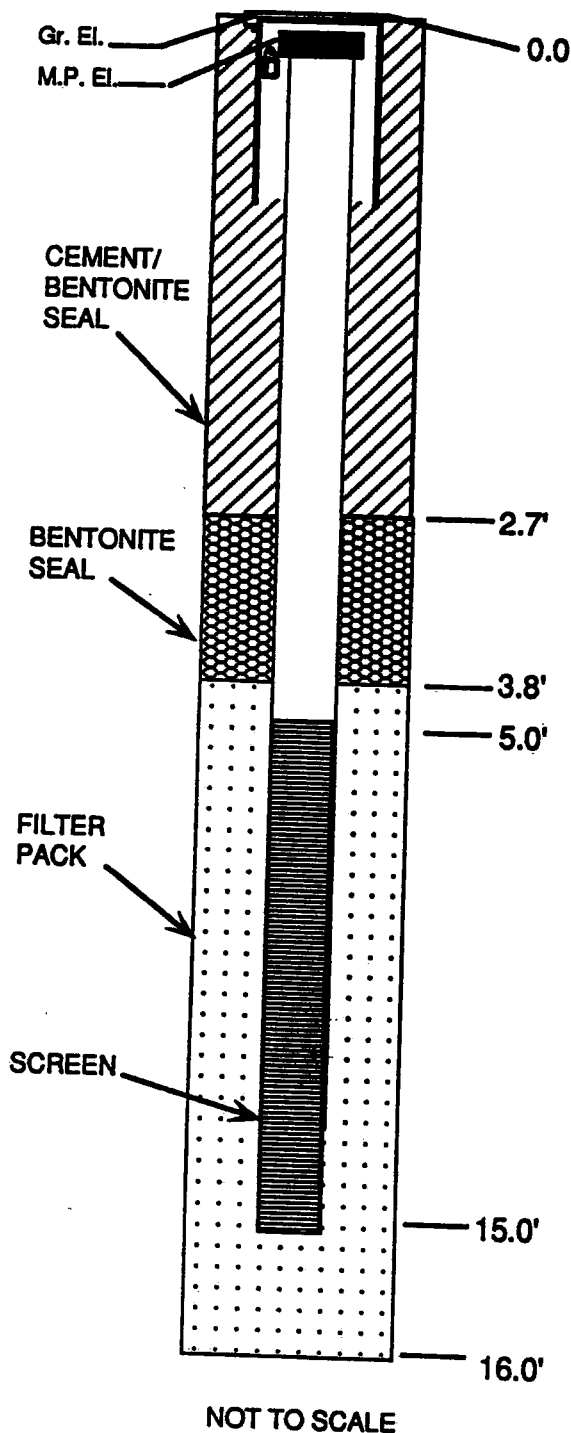
## WELL CONSTRUCTION DETAIL

Project Mearl Corporation  
 Client Mearl Corporation  
 Location Peekskill, NY  
 Project No. 02286-00244  
 Date Drilled 1/24/90  
 Date Developed 1/25/90

Inspector Christopher Gaule  
 Drilling Contractor Boyd Artesian  
 Type of Well Monitoring Well  
 Static Water Level                      Date                       
 Measuring Point (M.P.) PVC  
 Total Depth of Well 15.0'  
 Total Depth of Boring 16.0'  
 Drilling Method  
 Type Hollow Stem Auger Diameter 3" ID  
 Casing                       
 Sampling Method  
 Type Split Spoon Diameter 2"  
 Weight 140# Fall 30"  
 Interval Continuous  
 Riser Pipe Left in Place  
 Material Sch 40 PVC Diameter 2"  
 Length ~5.0' Joint Type Flush Thread  
 Screen  
 Material Sch 40 PVC Diameter 2"  
 Slot Size 0.010" Length 10'  
 Stratigraphic Unit Screened                       
 Filter Pack  
 Sand X Gravel                      Natural                       
 Grade 0  
 Amount 2-1/2 buckets Interval 3.8' - 16.0'  
 Seal(s)  
 Type Cement grout Interval 0' - 2.7'  
 Type Bentonite pellets Interval 2.7' - 3.8'  
 Type                      Interval

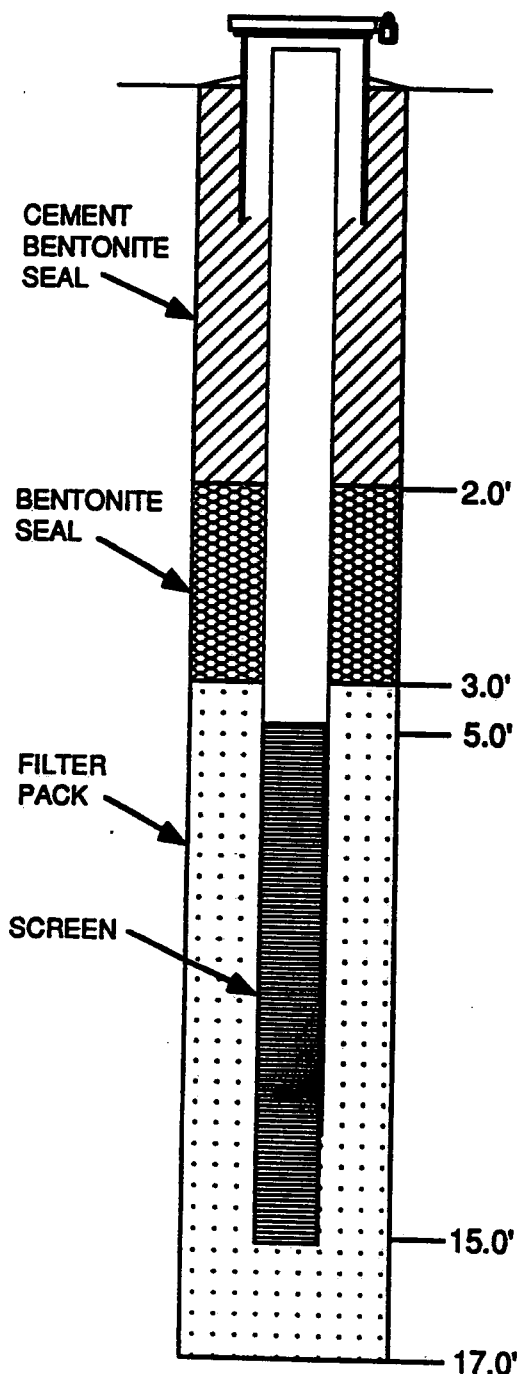
## WELL CONSTRUCTION DETAIL

Project Mearl Corporation  
 Client Mearl Corporation  
 Location Peekskill, NY  
 Project No. 02286-00244  
 Date Drilled 1/25/90  
 Date Developed 1/25/90

Inspector Christopher Gaule  
 Drilling Contractor Boyd Artesian  
 Type of Well Monitoring Well  
 Static Water Level            Date             
 Measuring Point (M.P.) PVC  
 Total Depth of Well 15.0'  
 Total Depth of Boring 17.0'  
 Drilling Method  
 Type Hollow Stem Auger Diameter 3" ID  
 Casing             
 Sampling Method  
 Type Split Spoon Diameter 2"  
 Weight 140# Fall 30"  
 Interval Standard  
 Riser Pipe Left in Place  
 Material Sch 40 PVC Diameter 2"  
 Length ~7.5' Joint Type Flush Thread  
 Screen  
 Material Sch 40 PVC Diameter 2"  
 Slot Size 0.010" Length 10'  
 Stratigraphic Unit Screened             
 Filter Pack  
 Sand X Gravel            Natural             
 Grade 0  
 Amount 3 buckets Interval 3.0' - 17.0'  
 Seal(s)  
 Type Cement grout Interval 0.0' - 2.0'  
 Type Bentonite pellets Interval 2.0' - 3.0'  
 Type            Interval             
 Locking Casing ☒ Yes ☐ No  
 Notes:
